DESCALING WITH ELECTRICITY

(Based on an article from Engineering Technology, June 1999)

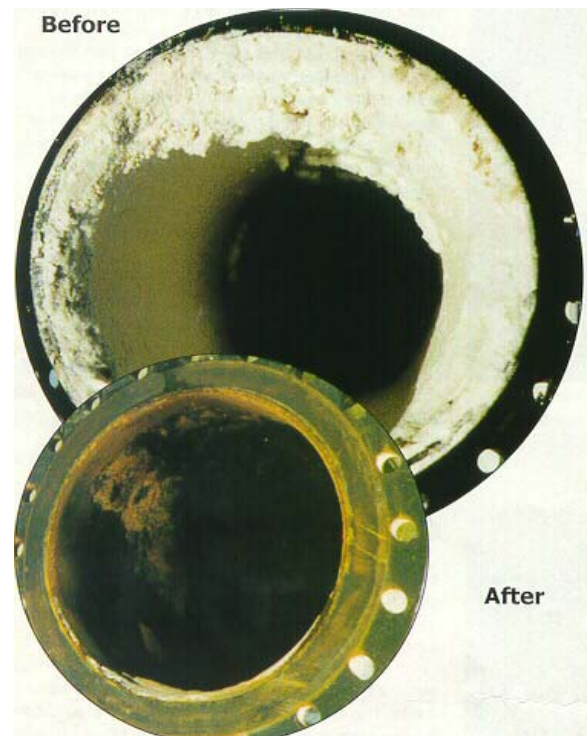
Fig 3: Typical scale formation, before and after Scalewatcher treatment

The calcium causes major fouling problems by laying down scale deposition layer by layer.

After three months, an inspection cover was removed some 150 metres downstream of the installation. Instead of rock hard scale usually found in the pipeline, the scale was soft and just a few millimetres thick.

This clearly showed that not only had *Scalewatcher* effectively prevented new scale formation, but was also removing existing deposition.

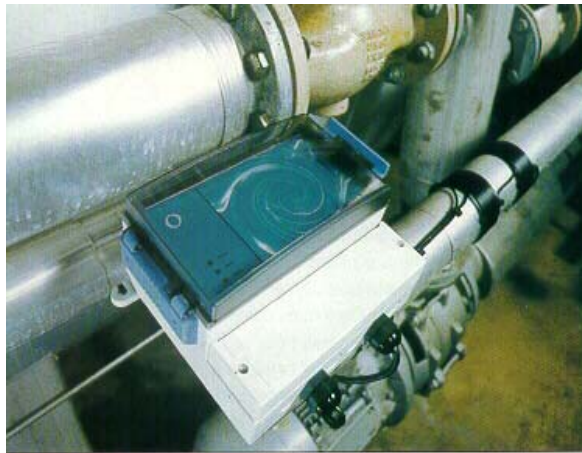
Fig 4: A typical *Scalewatcher* installation. Note the tightly wound coils in the centre right of the photo.

A *Scalewatcher*[®] unit was installed on to the feed to the No. 1 clarifier.
